FACILITY COMPLIANCE INSPECTION REPORT

Division of Waste Management Solid Waste Section

Date of Site Inspection: 2 February 2012 **Date of Last Site Inspection:** 31 October 2011

Beaufort County Closed MSW Landfill
1342 Hawkins Beach Road
Bath, NC 27808

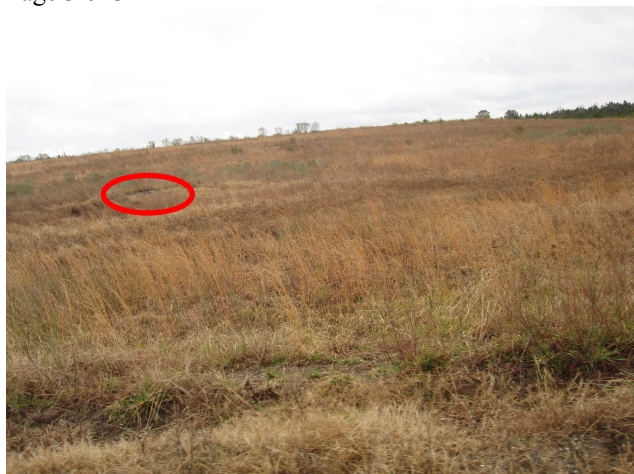
- 8) Overall, the landfill has a well established cover crop of native warm season grasses. However, small areas of sparse cover were noted at several areas throughout the landfill. *To maintain the integrity of your landfill cap system, please

- grade, seed, and mulch these areas to establish a groundcover suitable to prevent erosion.
- 9) Leachate was noted as seeping from the northern sideslope of the upper lift approximately halfway up the lift in the center of the sideslope. No leachate was noted as leaving the disposal boundary. *Within thirty days of receipt of this report, repair the landfill cap in the areas along the northern sideslope to prevent the further release of leachate from the landfill. All repaired areas should be graded at a slope not greater than 3:1, seeded, and mulched to establish a groundcover suitable to prevent erosion of the landfill cap system.

Overall well established cover crop-note area of cap damage w/leachate seep

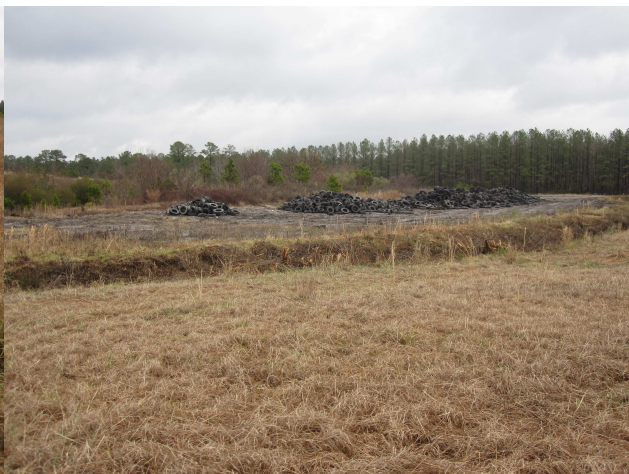
- 7) The scrap tire management element of your facility needs further attention. The storage pile is still too large and the tires have been deposited in a disorderly manner throughout the facility. *It is strongly recommended that transfer trailers be utilized at the site. All scrap tires should be placed directly into transfer trailers and stored there until transfer to the permitted tire management facility.

Scrap tire management area

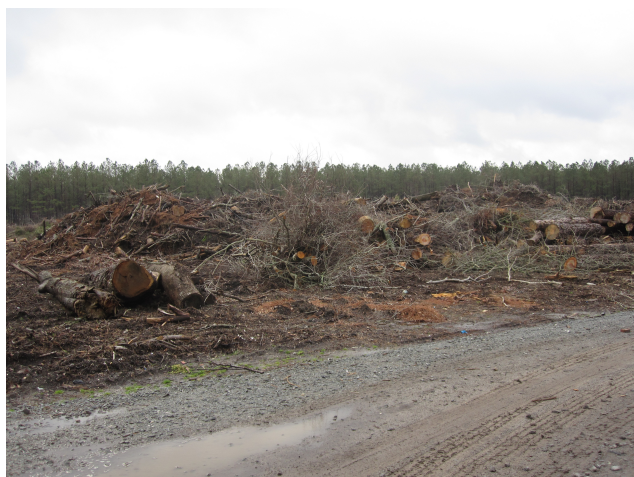
- 6) A large volume of vegetative debris still remains at the TDDMS. *Plans need to be underway for the processing and removal of this debris as soon as possible.

Vegetative debris stage for grinding

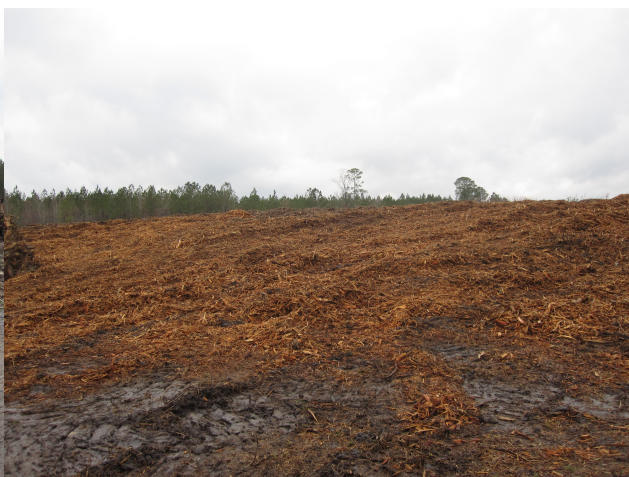
- 5) Some of the vegetative storm debris has been ground and is stored on-site adjacent to the landclearing debris element. No grinding operations were underway during this site visit.

Woodchips staged for reuse adjacent to the landclearing debris element
